Manhole Inspection Summary

Manhole # S37C__007MH

Insp Date: **8/22/08 8:48 AM**

Location Address: **224 n front st**

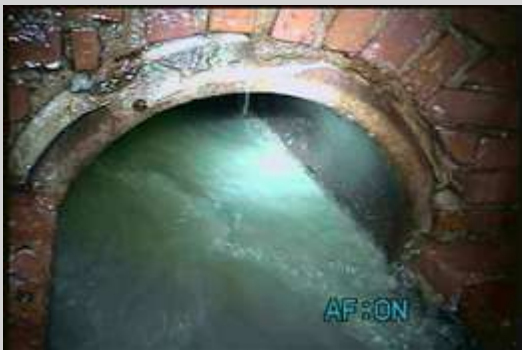
12 O'Clock Outflow

21 in. Circular Gravity Sewer
Pipe Out @ 12 O'Clock

Pipe Material: **Clay** ☐ Pipe Lined

Invert Depth: **14.00** (ft.) Flow Characteristics: **Fast**

Deposits: ☒ None ☐ Mud ☐ Sludge ☐ Debris ☐ Grease

Infiltration: **None** Pipe Seal Cond: **Unknown**

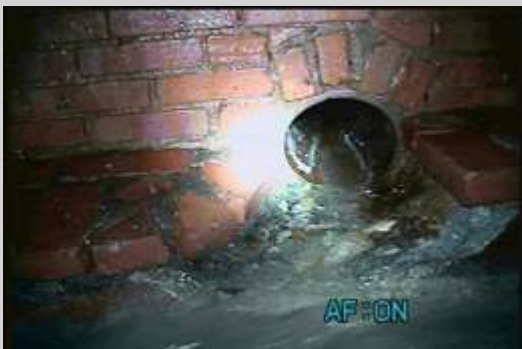
3 O'Clock Inflow

8 in. Circular Gravity Sewer
Pipe In @ 3 O'Clock

Pipe Material: **Clay** ☐ Pipe Lined

Invert Depth: **13.60** (ft.) Flow Characteristics: **Slow**

Deposits: ☒ None ☐ Mud ☐ Sludge ☐ Debris ☐ Grease

Infiltration: **None** Pipe Seal Cond: **Unknown**

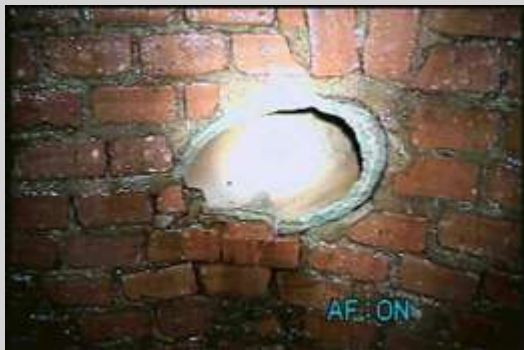
7 O'Clock Inflow

8 in. Circular Gravity Sewer

Pipe In @ 7 O'Clock

Pipe Material: **Clay** ☐ Pipe Lined

Infiltration: **None**
